SUBJECT: Yellow Water Road Dump Superfund Site

Five Year Review Report

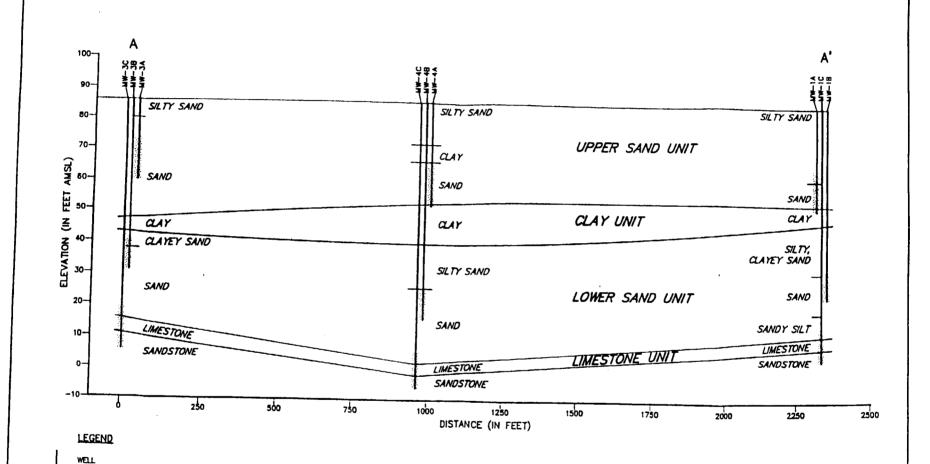
figure 3

GEOLOGIC CROSS—SECTION A—A'
YELLOW WATER ROAD SITE
Baldwin, Florida

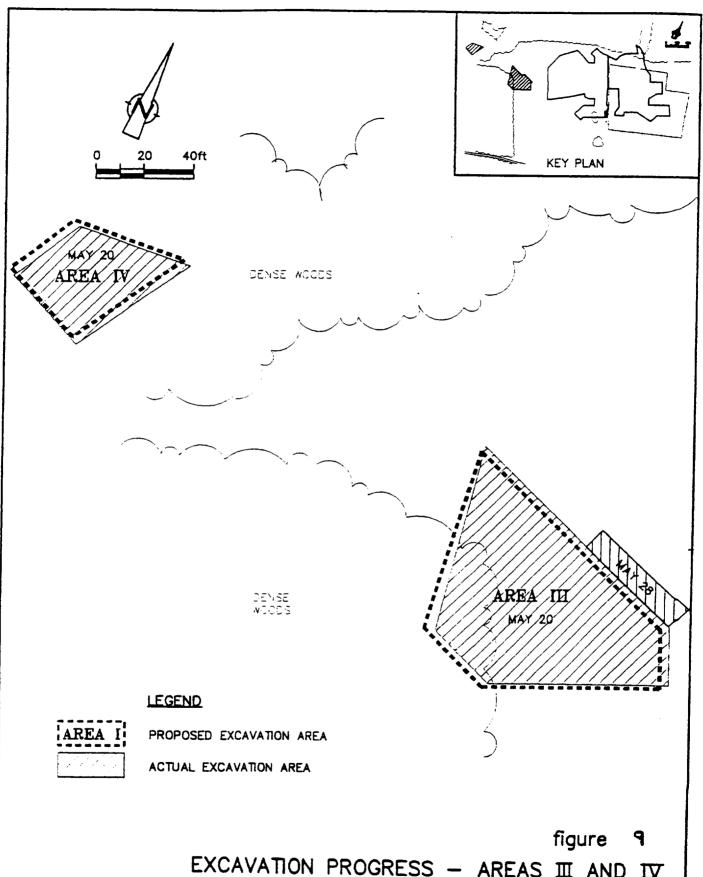
Excavation activities proceeded from the southern limits of Area I north to the slough at the northern limit of Area I. Excavations in the northern third of Area II, Area III and Area IV were completed prior to beginning the soil treating activities (see Figures 8 and 9). Soil excavation within the southern two-thirds of Area II was completed following completion of treating the stockpiled soils, thus facilitating access to the soils in this area.

EXCAVATION PROGRESS — AREAS III AND IV OU-1 REMEDIAL ACTION YELLOW WATER ROAD SITE Baldwin, Florida

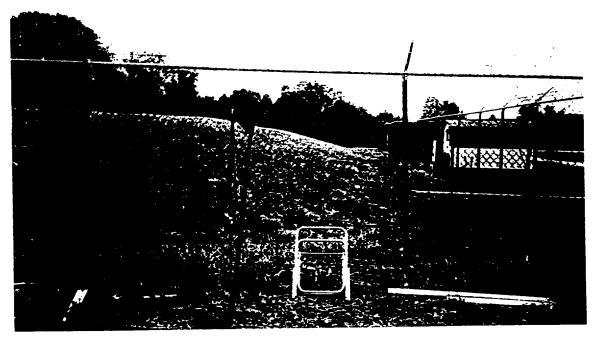
Photograph #3 June 27, 2000

Description: View of East Side of Monolith [facing north].

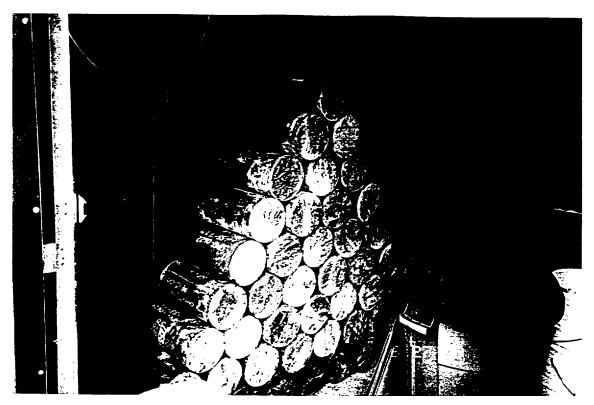
Photograph #11 June 27, 2000

Location: Yellow Water Road Superfund Site, Duval County, Baldwin, Florida. **Description:** Stored Samples of Monolith Material in Storage Shed.

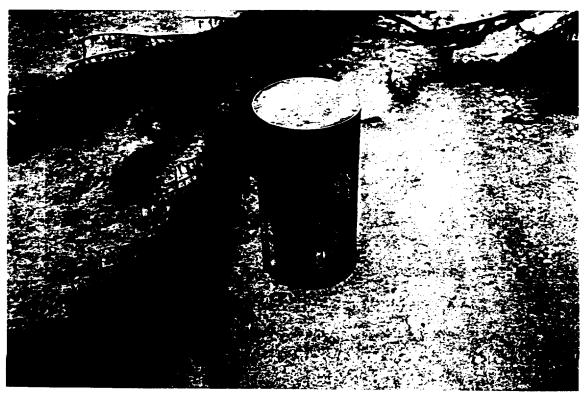
Photograph #12 June 27, 2000 Location: Yellow Water Road Superfund Site, Duval County, Baldwin, Florida.

Description: Solidified Sample Number 701.

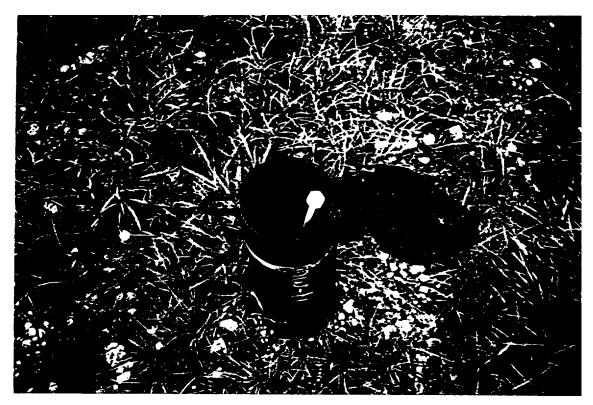
Photograph #15 June 27, 2000

Description: Monitoring Well MW-11.
